EXCAVATION AND SEISMOLOGY

HONEYWELL, INCORPORATED

PREPARED FOR
ADVANCED RESEARCH PROJECTS AGENCY
BUREAU OF MINES

MAY 1974

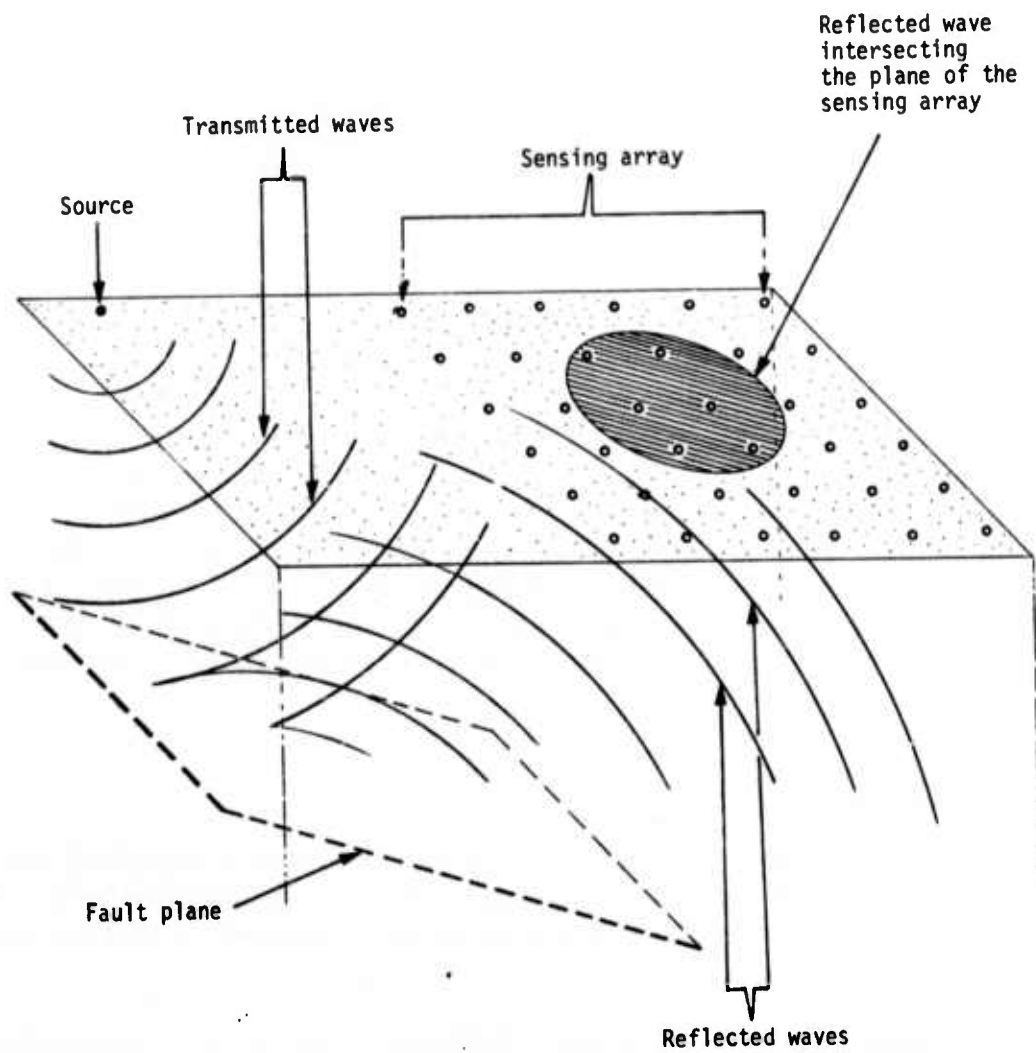
Figure 1. Detection of Fault by Sensing Array.

An acoustic pulse induced in the rock will propagate on a spherical wave front. This wave will be partially reflected at a fault, and the reflected wave can be detected by a plane array of acoustic sensing elements (see Figure 1).

As the reflected wave passes through the sensor plane, the intersection of the expanding wave front and the plane will be an expanding circle. The sensing element outputs at successive instants will show the positions of the expanding circle. A movie of the expanding circle can be made by constructing a set of pictures of the sensing array and showing the instantaneous sensor outputs on the pictures. Information about the reflecting surface can be gotten by measuring the images on the successive movie frames.

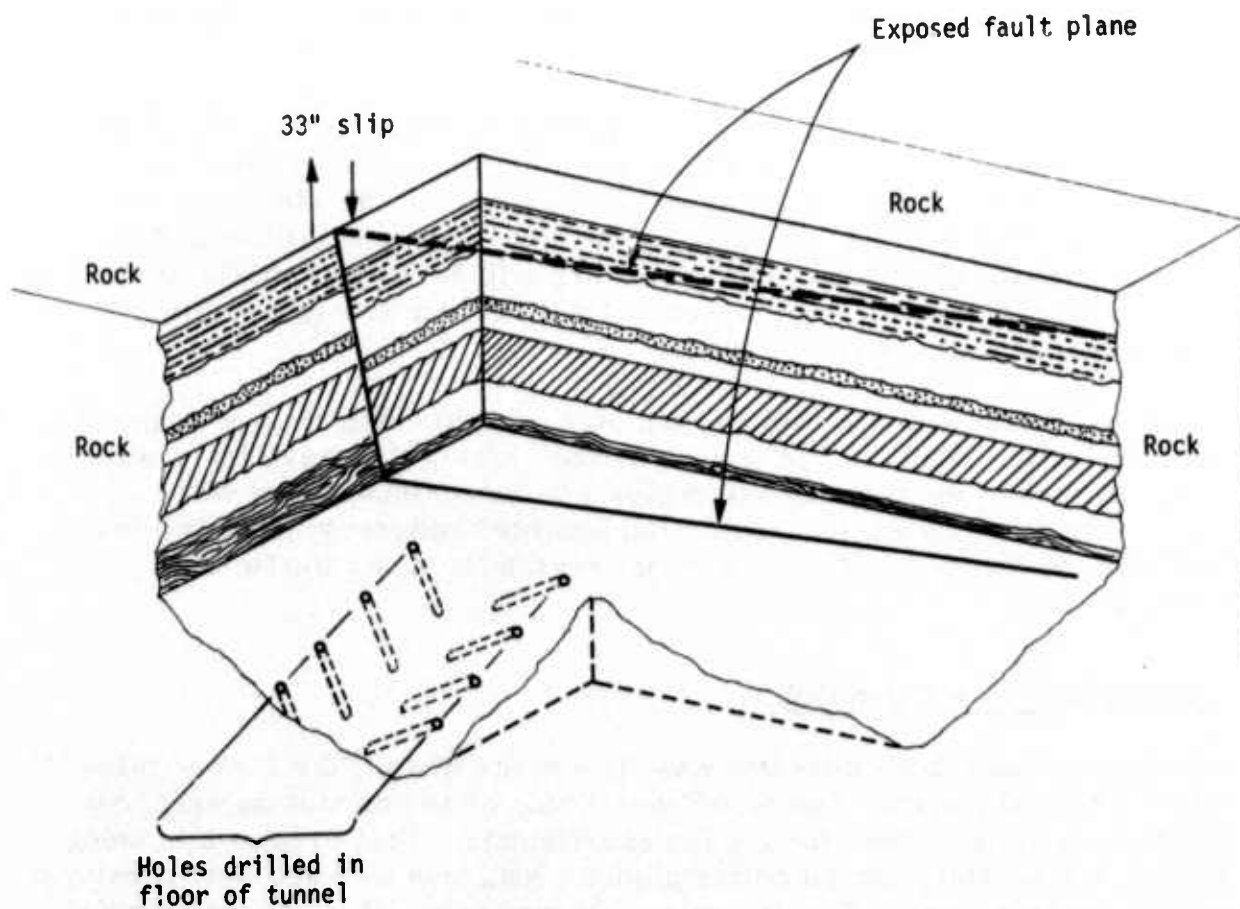
Figure 2. Cutaway View of Experimental Area.

The underground data collection was done in the White Pine Copper mine at White Pine, Michigan. The older part of this mine contains an area that has been frequently used for mining experiments. This area, while being neither a laboratory nor an active mining area, provided necessary features of both environments. Power, water, storage area, etc., needed for the equipment, were available as were White Pine technical personnel familiar with performing experiments in the underground environment. Also, the rock structure and exposed surface geometry were more like those of a working mine area than could be found in a surface quarry or simulated in the laboratory. Figure 2 depicts the data collection area.

Because of the fault, the tunnel makes a right angle turn at this point after penetrating approximately 8 feet beyond the fault. The fault is thus exposed on the back, ribs and floor, and there is a large, undisturbed rock mass beyond the fault. The holes for the source and the sensor were drilled into the tunnel floor (Figure 3). Four hole pairs were used, located nominally at distances of 4, 8, 12 and 16 feet from the fault. The plane

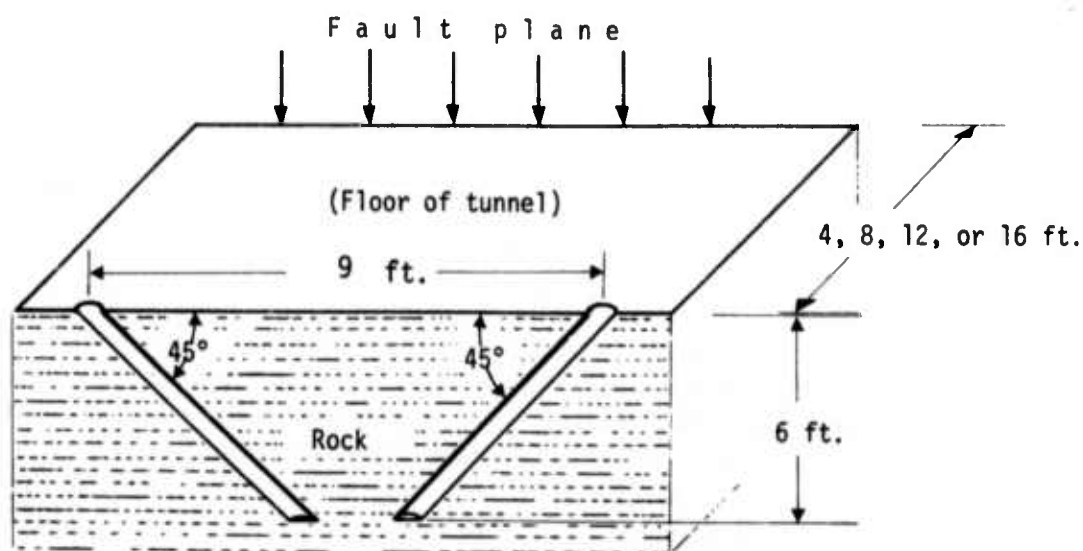
Figure 3. Nominal Arrangement of Test Hole Pairs.

defined by each hole pair was intended to be perpendicular to the tunnel floor and therefore not parallel to the fault. The actual holes were drilled manually by White Pine technicians and were put surprisingly close to the nominal positions and orientations. Each hole pair was slightly non-coplanar, but this did not interfere with the experiment. (On the contrary, it makes the experiment more realistic.)

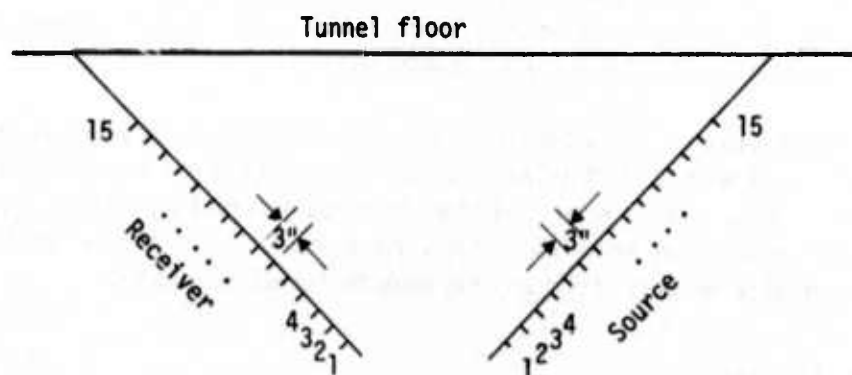
Figure 4. Nominal Source and Receiver Locations.

The majority of the experiments were performed using 15 source positions and 15 sensor positions. Figure 4 shows the nominal arrangement. The data collection procedure involved positioning the source and the sensor, discharging the source, recording and displaying the received signal interval and photographing the display. This was done for each of the 225 pairs of source and sensor positions. The line displays were recorded on adjacent line positions on film. Figure 5 shows the nominal structure of the film record. For each sensor position there are 15 adjacent lines corresponding to the 15 source positions, and there are 15 such groups of lines corresponding to the 15 sensor positions.

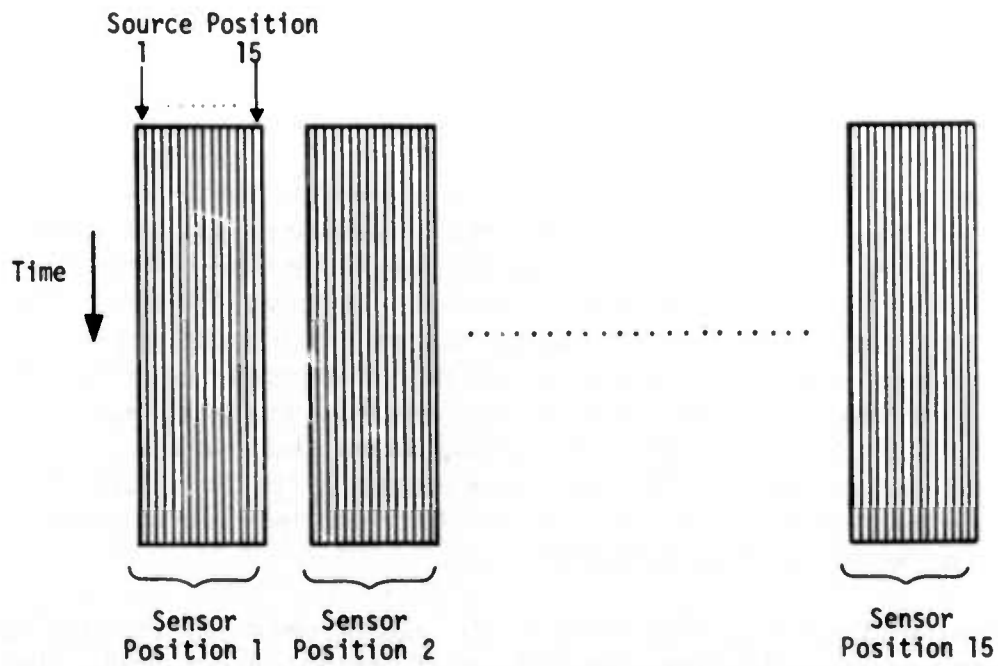
Figure 5. Nominal Film Recording Format.

Of 15 complete recordings, (i. e., format of Figure 5) made using four different hole pairs, only one record, from the hole pair located 4 feet from the fault, showed the reflected wave. The computer processing needed to make this reflected wave visible is described in Section IV. The remaining recordings, made from the same hole pair and at the 8 ft., 12 ft. and 16 ft. hole pairs, all show the direct wave, but the reflected wave was too obscured to be made visible in the movies.

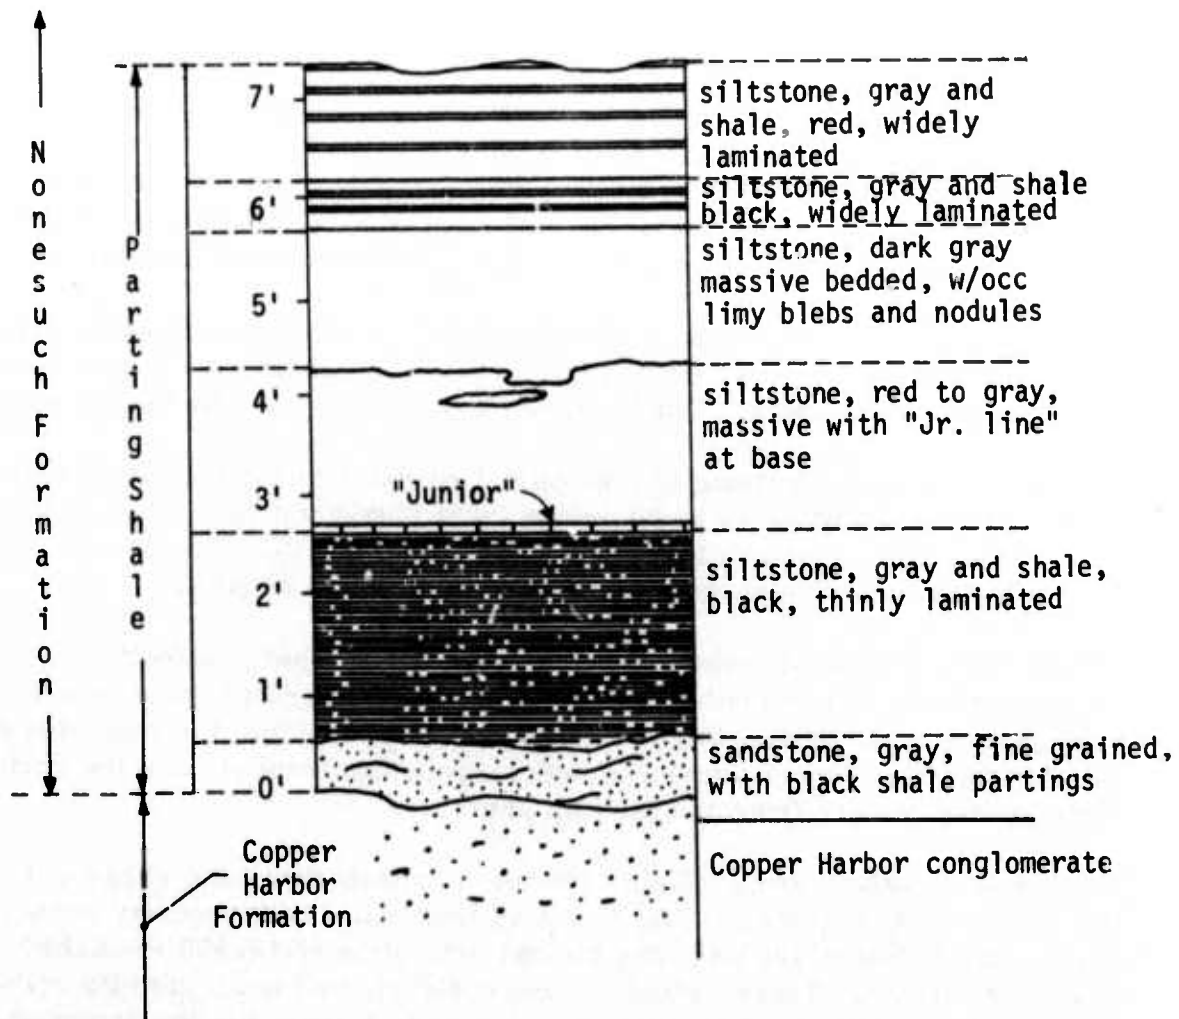
Figure 6. Geology of Ore Column in the Experimental Area.

The experimental area was located within the Upper Keweenaw Series in the White Pine District at the bottom of the Nonesuch Shale. Figure 6 shows a cross section through the drift. The rock surface on which we worked was approximately at the 0' level in Figure 6. This is the top of the the Copper Harbor Conglomerate into which the test holes were drilled. Figure 7 shows the geometry of the fault that was being studied. A fractured rock zone extended one to two feet on either side of the fault.

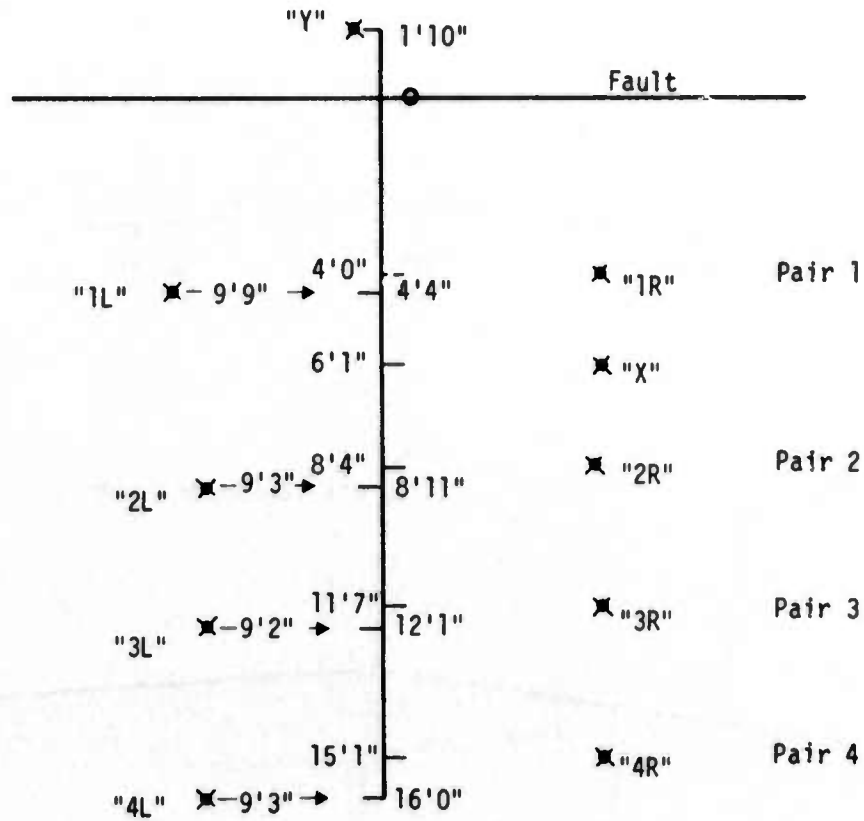
Figure 8. Locations and Names of the Test Holes.

Figure 8 shows the locations of the holes drilled for these experiments. This figure also shows the names (1L, 1R, X, etc.) that were used to denote the individual holes. These names are used in the test of this report.

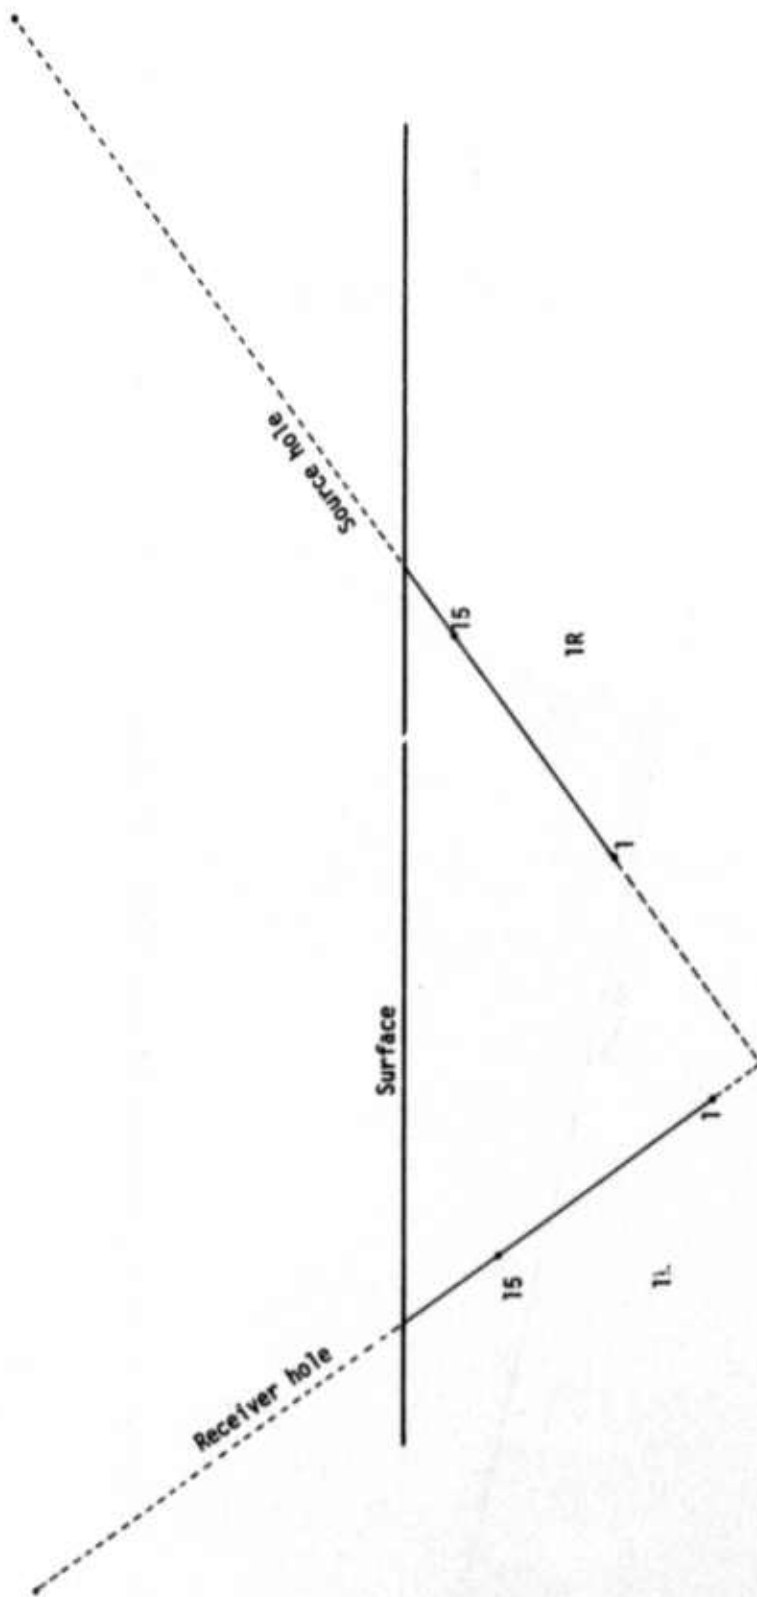
Figure 9. Scale Drawing of Hole Pair 1 Projected onto the Fault Plane.

Figure 9 is a scale drawing of hole pair 1 projected onto the plane of the fault. This and Figure 10 were drawn from measurements made at the site. The ideal 45 degree angles were not obtained, but this did not interfere with the experiment or the interpretation of the results.

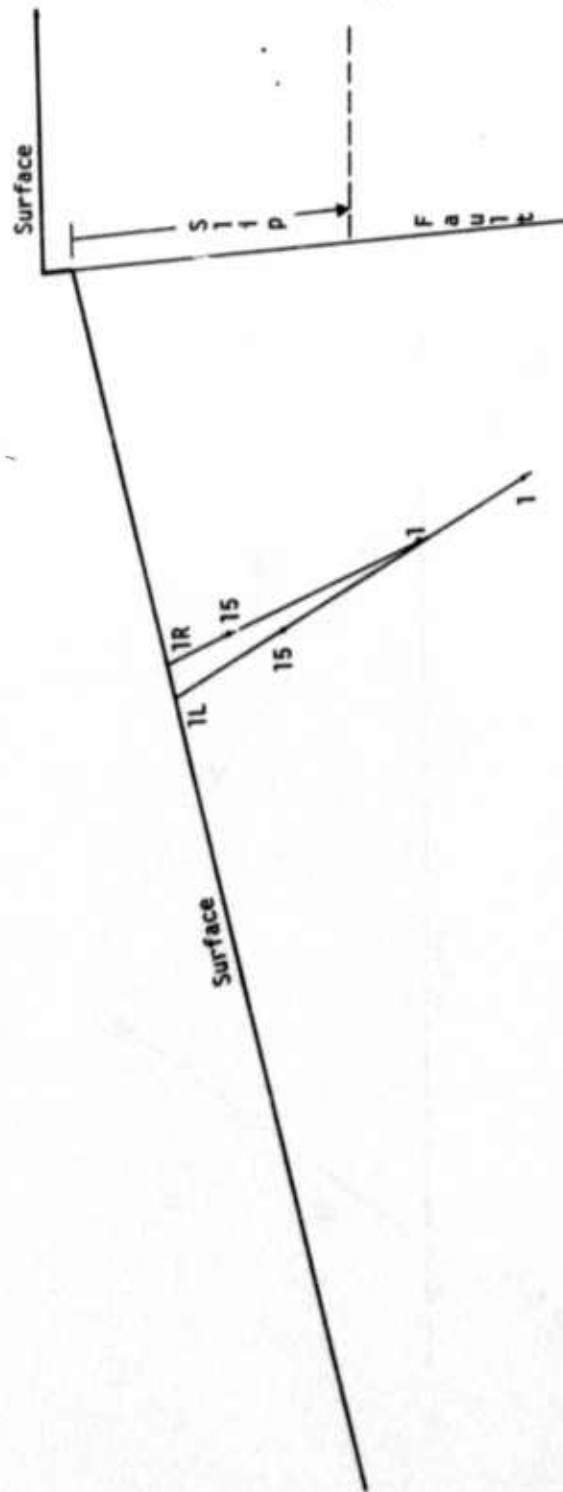
Figure 10. Scale Drawing of Hole Pair 1 Projected onto a Plane Perpendicular to the Fault.

Figure 10 is a scale drawing, perpendicular to the fault, showing the actual angles made by the two holes of hole pair 1. The parting shale location is also shown on the downside of the fault. This shows that the transmission was through the Copper Harbor Conglomerate (sandstone), and the reflections probably were from the parting shale.

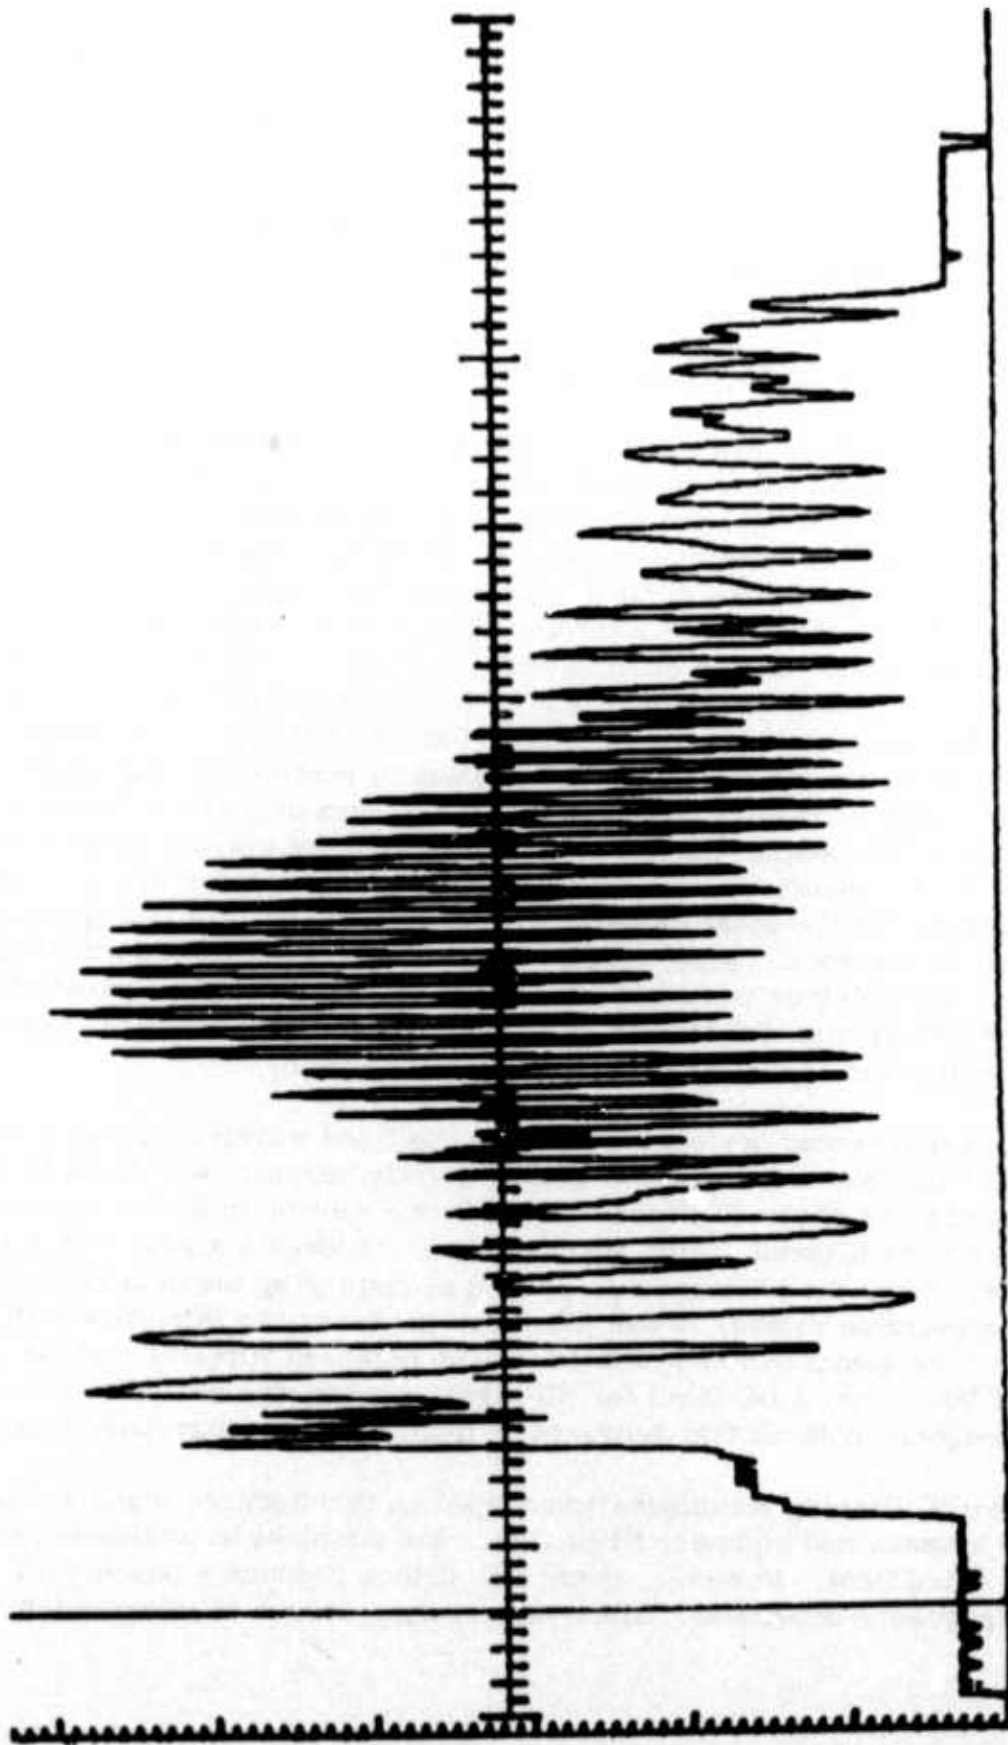
Figure 11. 500 Point Display of Digitized Sweep.

A typical raw waveform is shown in Figure 11. This is one of the waveforms that was obtained on the final data collection trip. It shows a slowly varying DC level that was probably due to the equipment. All of the equipment used during the experiments was AC coupled. The waveforms collected on the earlier trips did not show this DC level variation. The earlier trips concentrated primarily on low contrast photographs, while the final data collection trip concentrated on high contrast photos. The high gains that were needed to obtain the signals that would produce high contrast photographs may have saturated one or more of the amplifiers. This saturation could then have caused the DC level variation in response to signal pulse arrivals. Another feature of this signal is the presence of a 6 kilohertz pulse early in the signal waveform and a 12 kilohertz ringing pulse appearing later in the waveform. No experimental explanation for this phenomena was obtained, but the most probable explanation is that this is a filtering effect due to the rock. Also, in the waveforms produced when either the source or the receiver were near the rock surface, there is a persistence of a 12 kilohertz signal that lasts to the end and in many cases far beyond the end of the 5 millisecond sweep that was recorded.

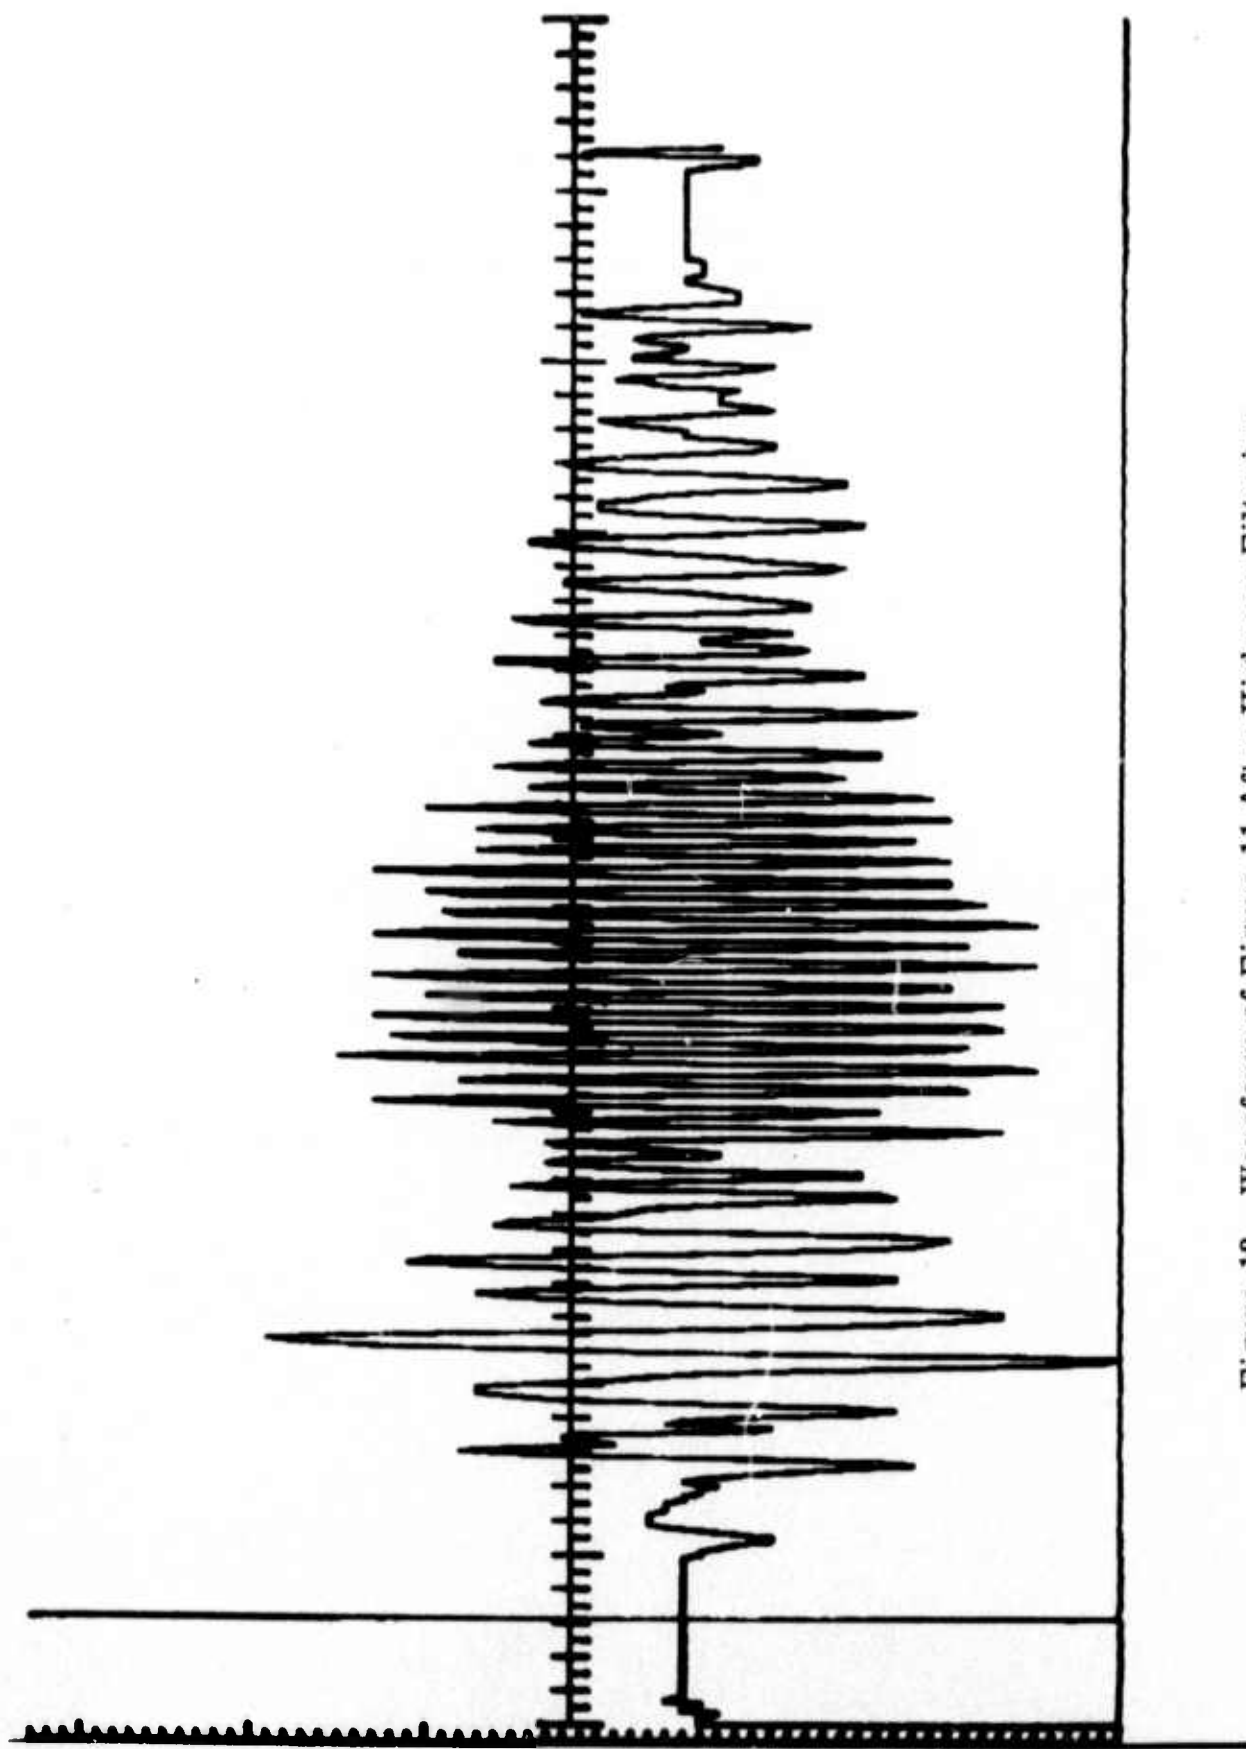
Figure 12. Waveform of Figure 11 After Highpass Filtering.

The primary filtering performed on these digitized waveforms was a high-pass filter that was used to eliminate the slowly varying DC. Results of this filtering are shown in Figure 12 where the waveform in the previous figure has been filtered. High pass filtering produces a signal with a zero DC value. Since the photographic method of displaying the data does not allow for negative values, it was therefore necessary to introduce a DC bias after the signal had been filtered. The highpass filtering and the addition of the constant DC level for all signal sweeps was found to eliminate the herringbone pattern that appeared in most of the photographed imagery.

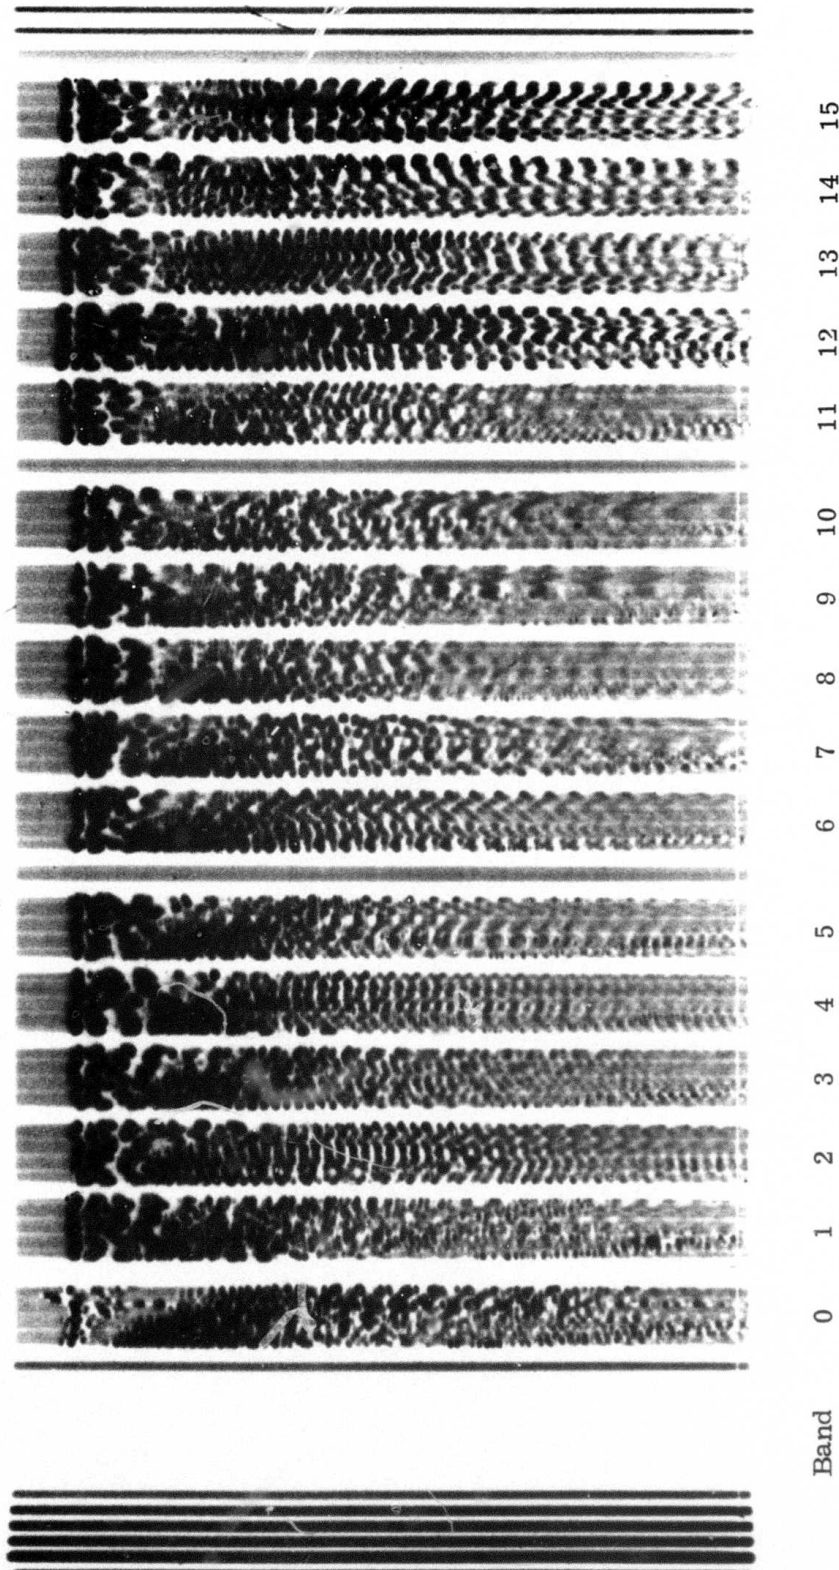
Figure 13. Frame 16: Data Recording from Hole Pair 1.

Figure 13 is an enlargement of frame 16 as it was recorded during the experiment. The various problems discussed earlier (extra bands, herringbone, flare, misalignment of trigger pulse) are all present in this frame. Band 0 was made using the external trigger, which was not operating properly. This band was not used for the data analysis. Bands 1 - 15 are the array recording and were made using internal trigger. A movie made from this frame, without processing, showed none of the expected features. Figure 14 shows frame 16 after the sweeps have been aligned by the first peak. (The sweeps were shifted in the computer so that the first maximum of the direct wave was in the same location in each digital record.) This alignment is not perfect, as the ragged appearance of the dark strip near the top of each band shows. (This is the peak used for

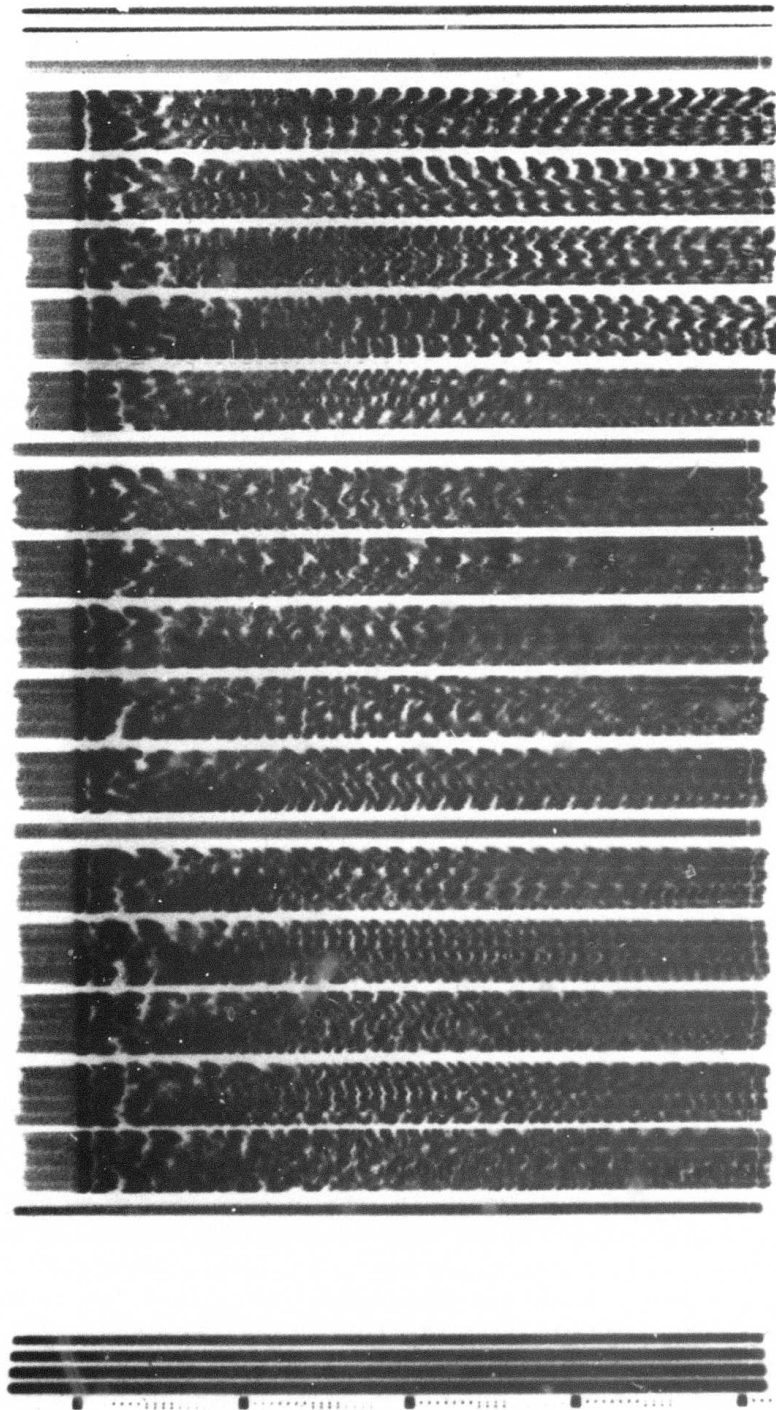
Figure 14. Frame 16 Aligned by First Peak.

alignment.) A movie made from this aligned version of frame 16, but with no other processing done on the data, showed dark movie frames corresponding to the first peak but no indications of any other direct or reflected waves.

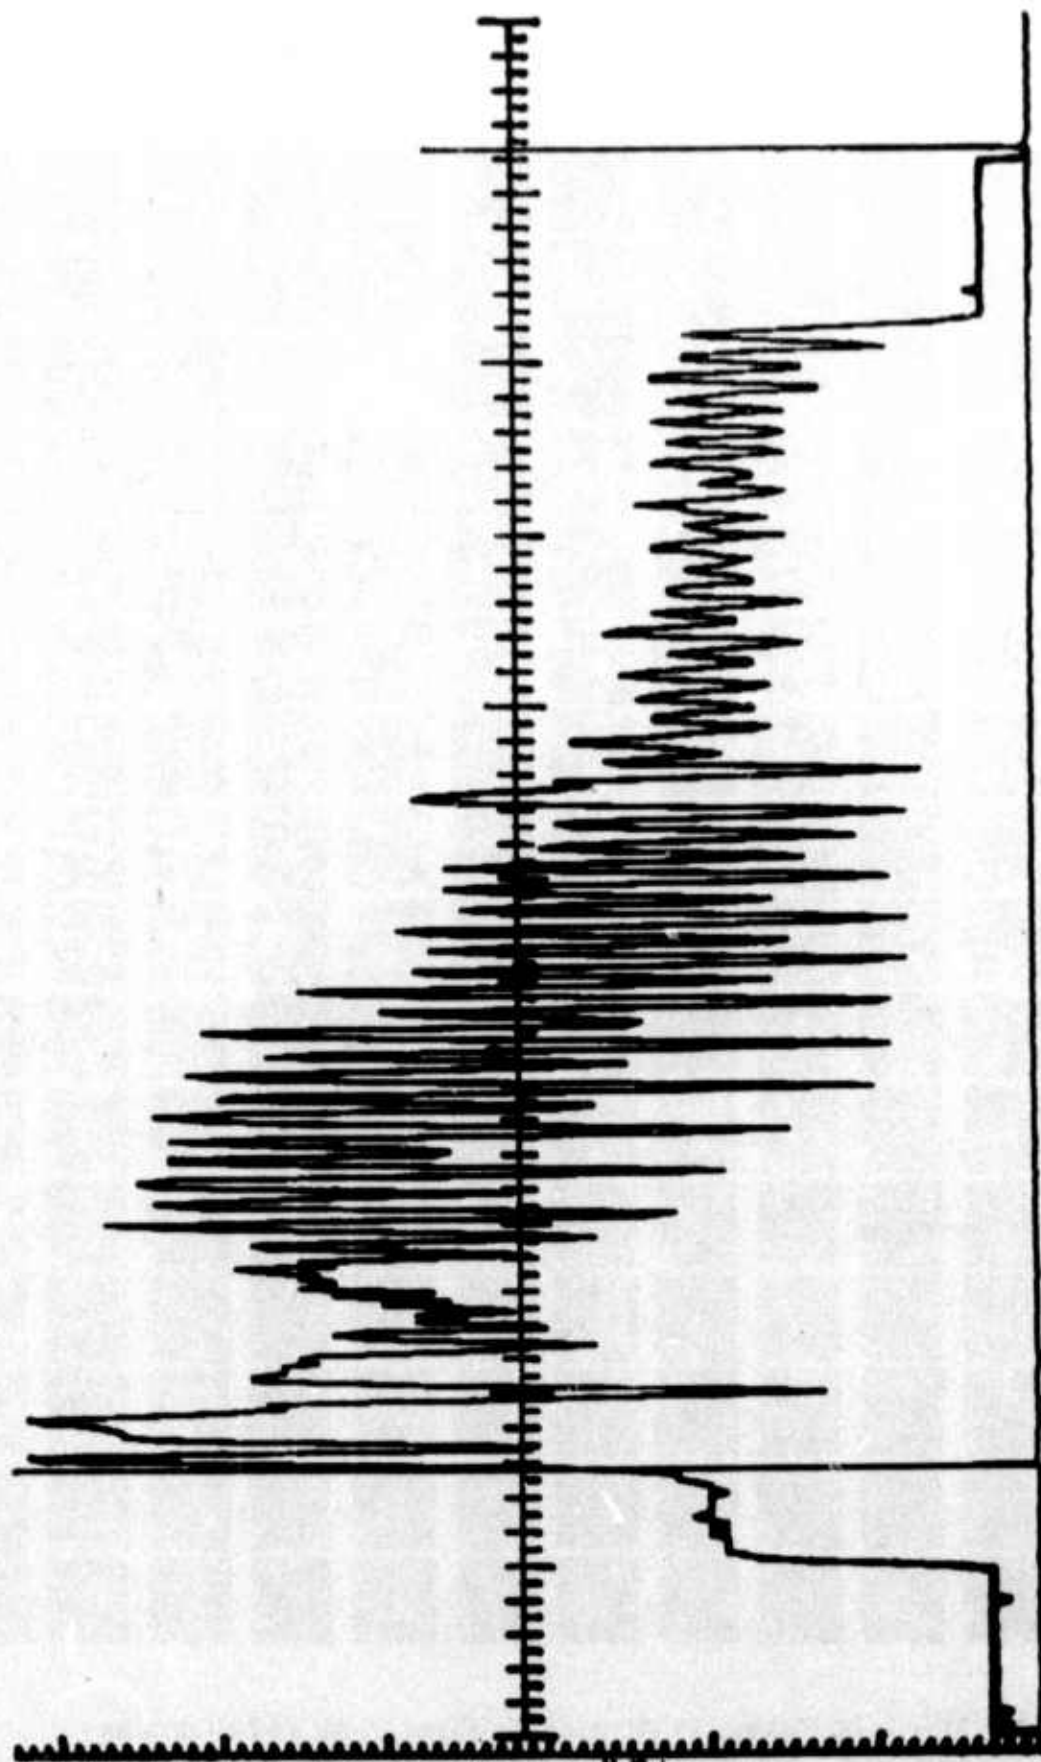
The second generation editing concentrated on the 6 kHz and 12 kHz frequency regions. Figure 16 shows the sampled time waveform for line 12, band 13. This is the 500 point edit display with each small interval on the time axis representing five samples or $70 \mu\text{s}$. The large DC level shift is a dominant feature of the unedited waveforms. The 6 kHz and 12 kHz components can be easily seen in the alternating negative peaks. Because they are simple to implement, the first kind of bandpass filter used was the recursive. Using recursive filters of various orders and bandwidths gave no positive results. The most likely explanation for their failure is that they introduce a phase shift that obscures or destroys the phase relations that would reveal the reflected wave in the movie.

Figure 16. Figures 16-18 Show a Digitized Waveform and the Result of Bandpass Filtering It at 12 kHz and 6 kHz.

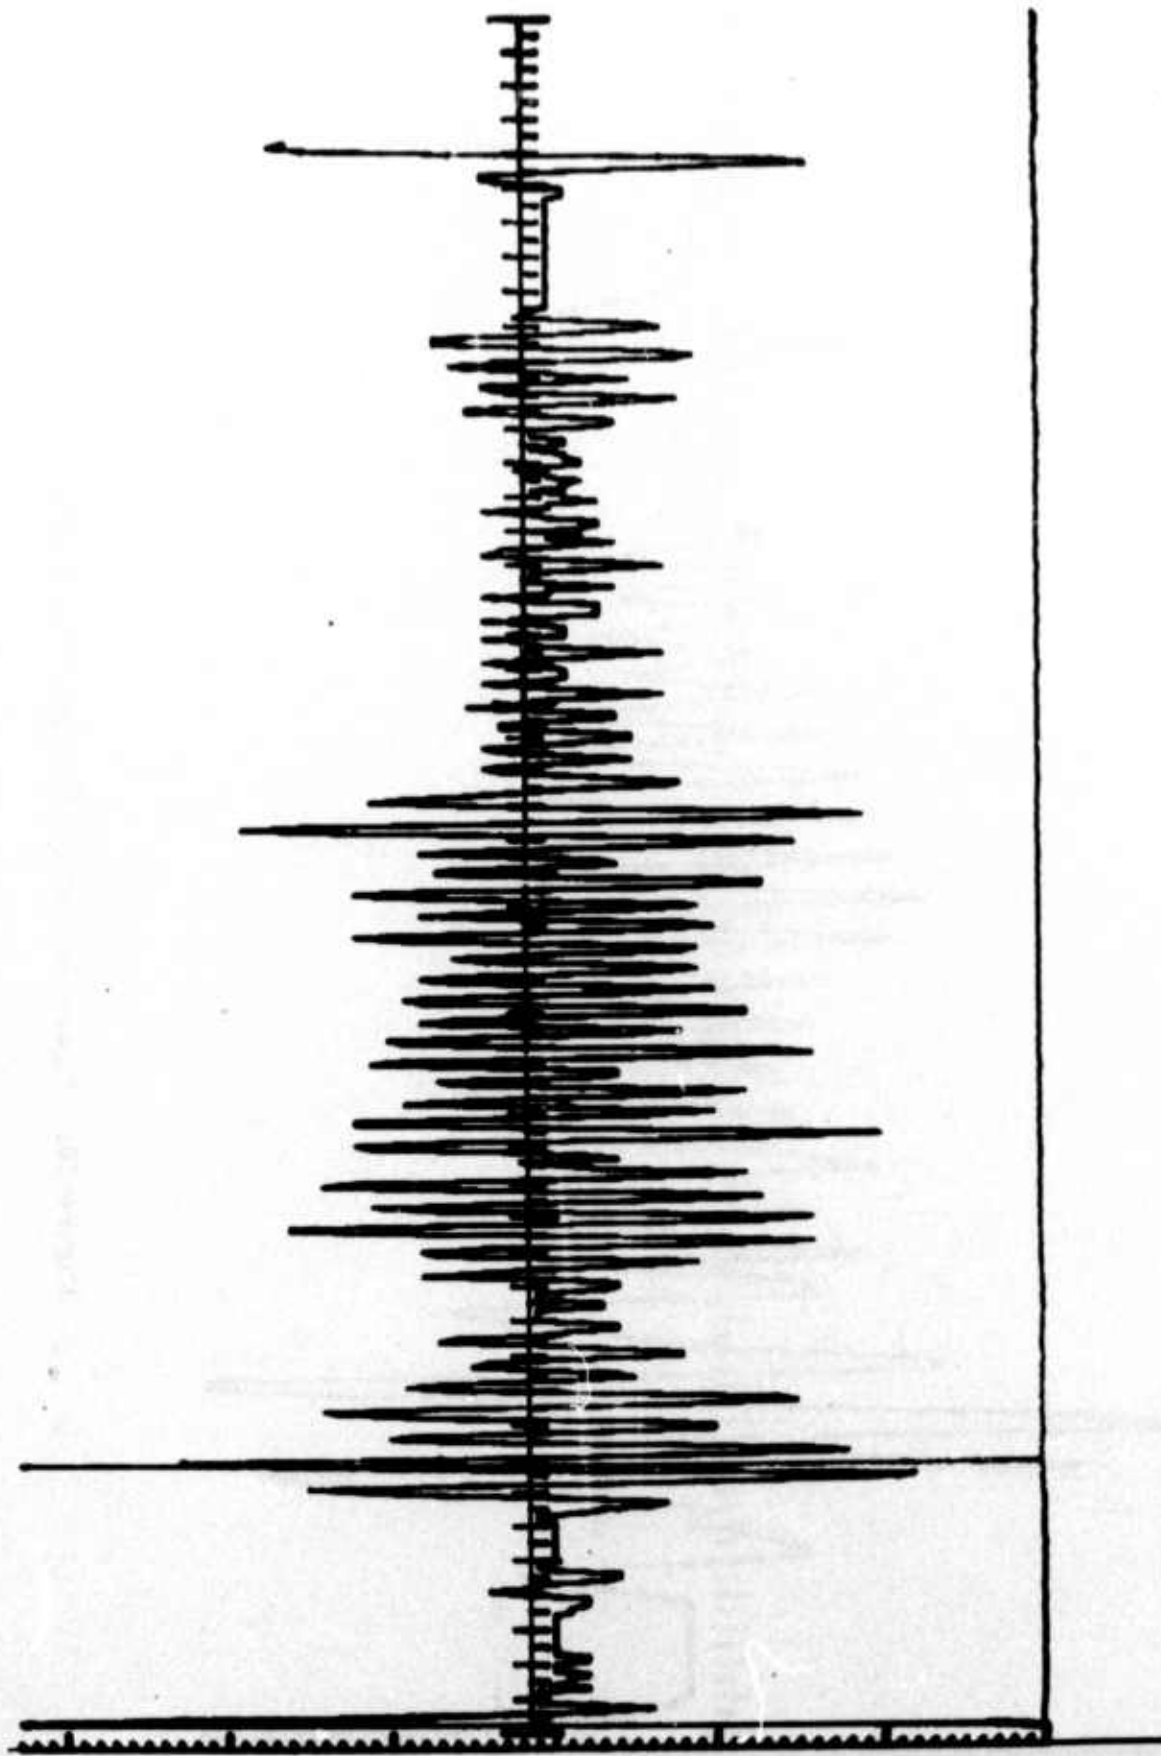
Figure 17. Figure 16 Bandpass Filtered at 12 kHz.

The next bandpass filtering method tried used a modified Hamming window that does not produce a phase shift. Figure 17 shows the waveform in Figure 16 after being filtered in this way. The passband in Figure 17 is 8 kHz - 14 kHz. Figure 18 shows line 13 of band 13 (adjacent line to Figure 17) filtered through a passband of 5 kHz - 7.5 kHz. The former filter produced no results, but the later one gave the movie shown in Figure 19. This movie shows the direct p-wave, the direct s-wave, and the reflected s-wave.
